Inspection Report

RIVIERA BEACH REDEVELOPMENT AGENCY

Property Address:
2601 Broadway
Suites 1, 2, 3
Riviera Beach FL 33404

BEATTY INSPECTION SERVICES

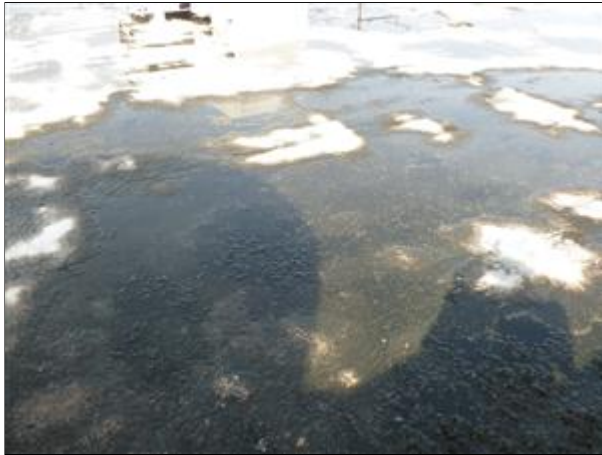
1.0 There is a roof design flaw in that the roof does not contain sufficient pitch to eliminate standing water.

Roof Showing Standing Water

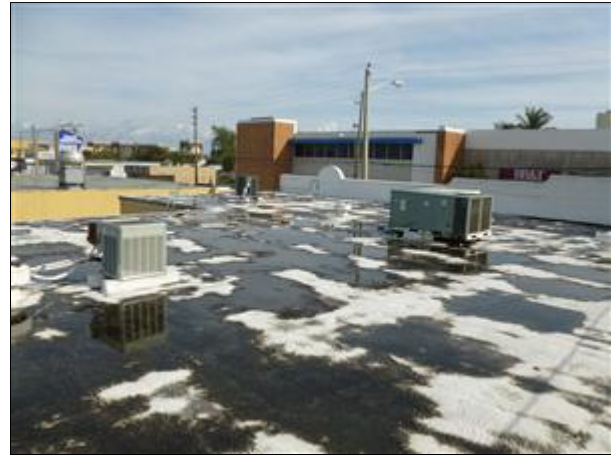
Roof Surface

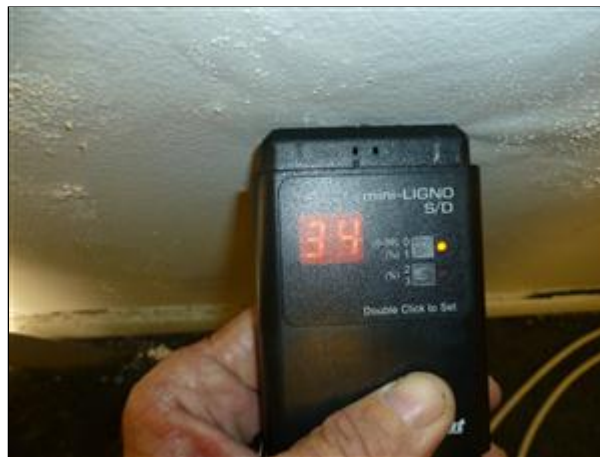
1.1 The South wall of the West office has high levels of moisture with live mold. It is believed that this moisture is being introduced into the interior from faulty roof flashing.

Elevated Moisture - Suite 3

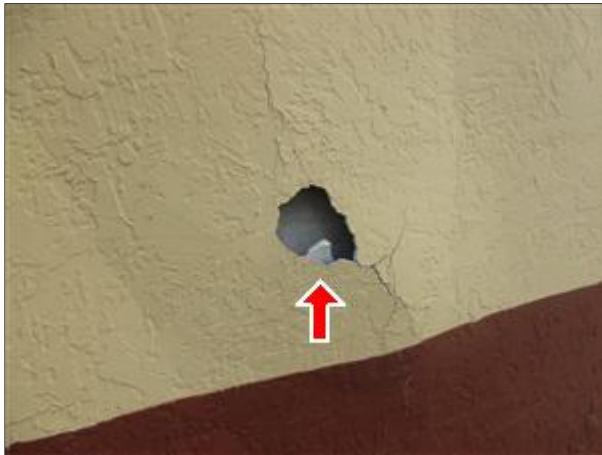
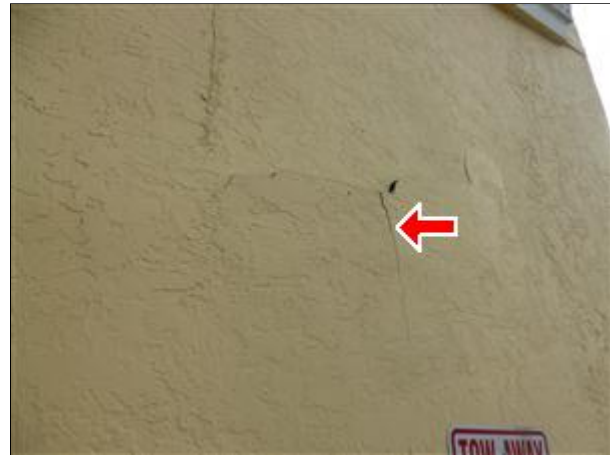
2.0 The stucco is starting to spall in several areas. These areas will need to be repaired.

Spalling Stucco - Exterior

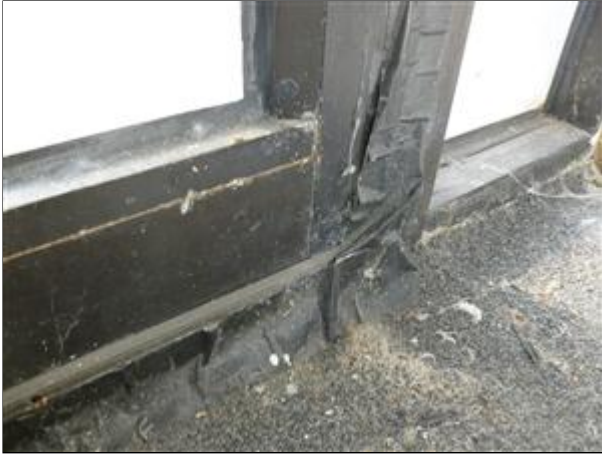
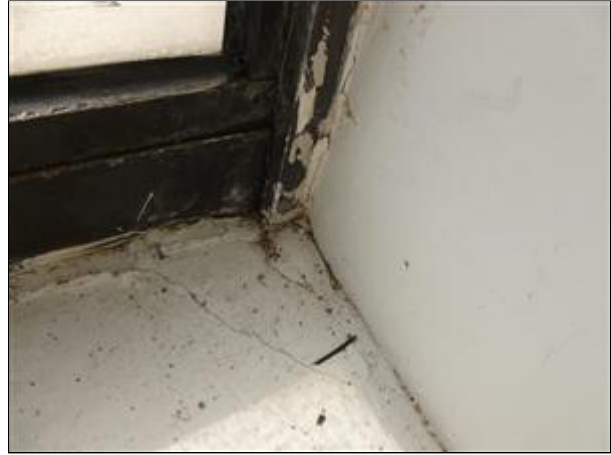
2.1 The exterior doors are damaged, deteriorated and require replacement. (All Suites).

Damaged Door - Suite 3

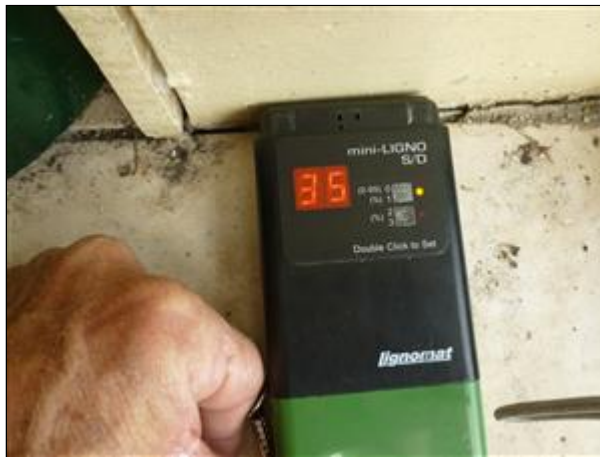
Front Entry Moisture - Suite 1

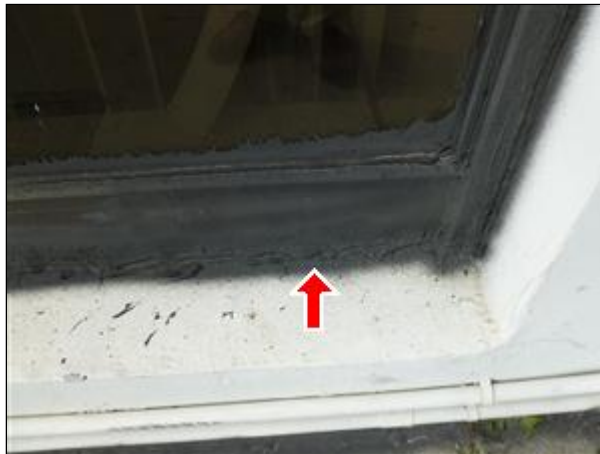
2.2 The windows are allowing moisture to enter the interior. Recommend replacement.

Deteriorated Window - Suite 2

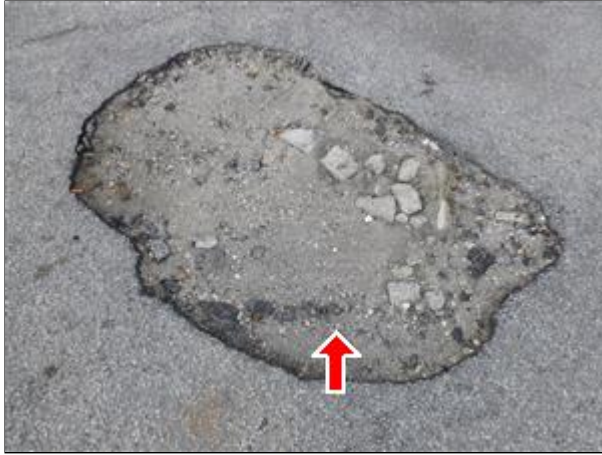
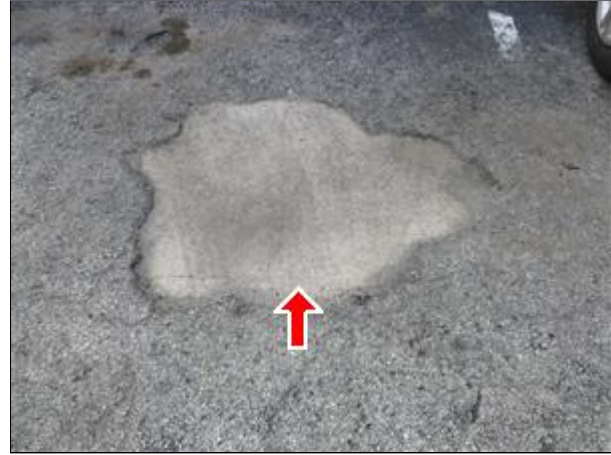
2.3 The exterior parking area asphalt is damaged and deteriorated. Recommend re-asphalting.

Damaged Asphalt

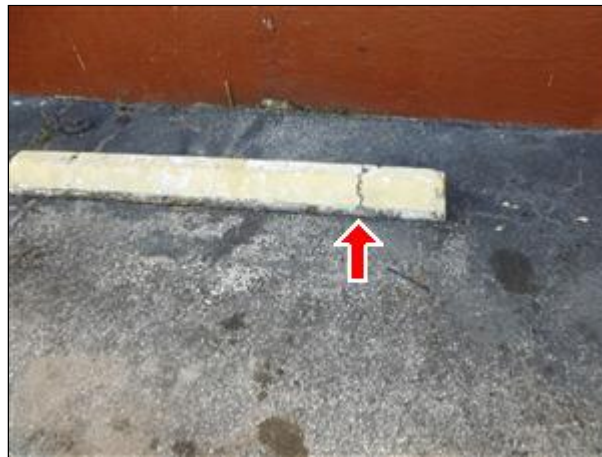
Damaged Car Stop

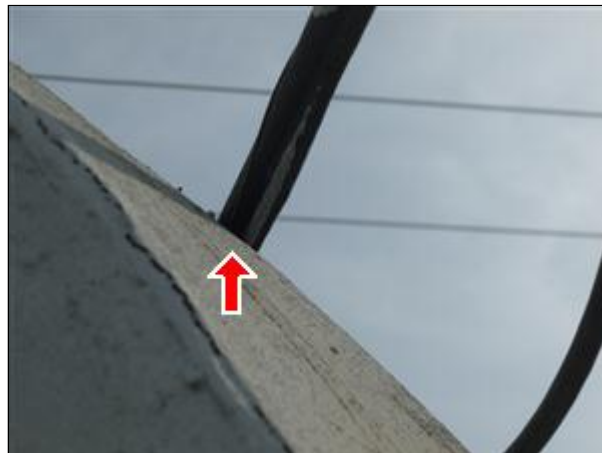
2.5 Utility wires are rubbing against the building. (Utility company to address).

Utility Wiring - Front Fascade

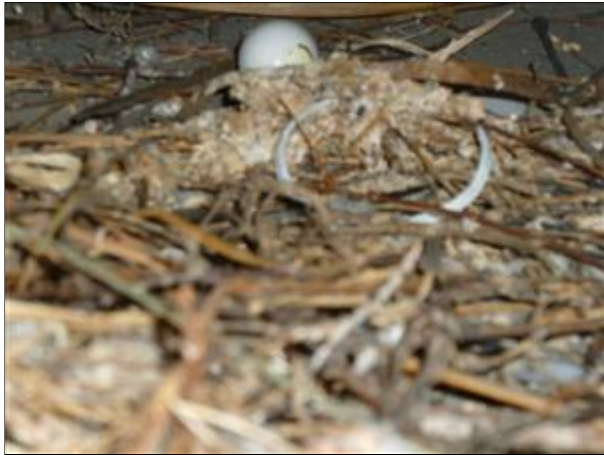
3.0 There is a pigeon nest in the suspended ceiling. This is affecting the indoor air quality. (Suite 3).

Pigeon Nest - Suite 3

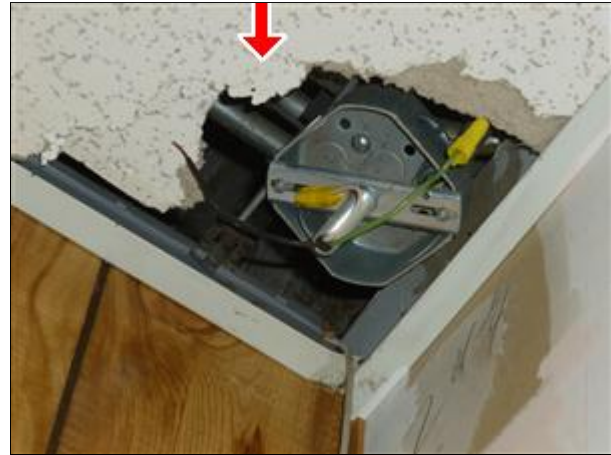
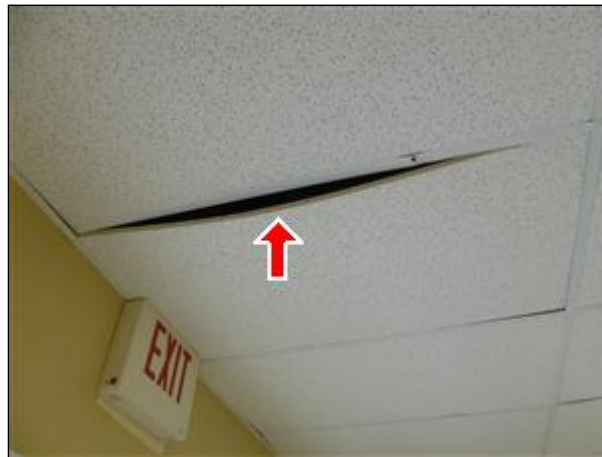
The suspended ceiling is damaged in several areas. (Suite 1 and 3).

Damaged Ceiling

Damaged Ceiling - Suite 1

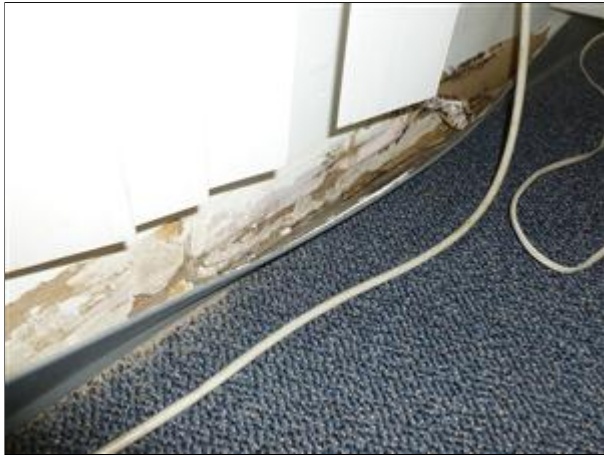
3.1 There were moisture stains on the East wall of the North office area under the windows. The vinyl base is not secured. This area was checked with a moisture meter and elevated levels of moisture were detected indicating leaking around the window frame. (Suite 2).

Damaged Floor Base - Suite 2

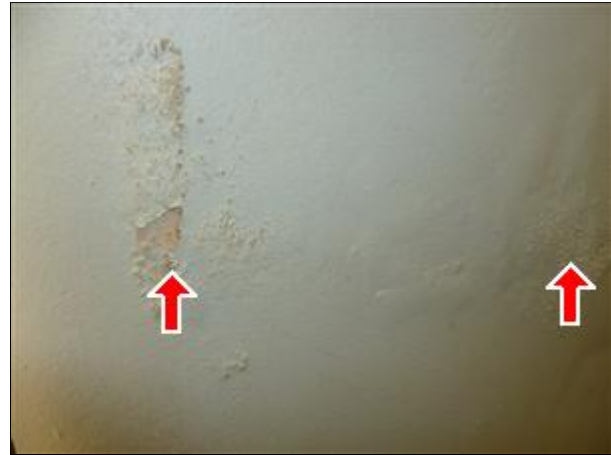
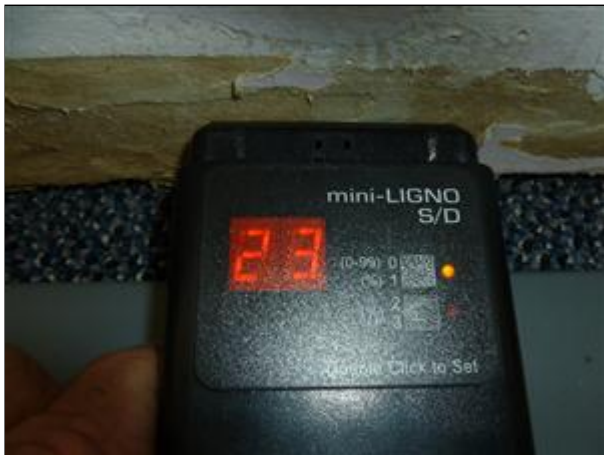
There are moisture stains on the South wall of the West office. This area was checked with a moisture meter and elevated levels of moisture were detected. (Suite 3).

Moist Wall - Suite 3

Elevated Moisture - Suite 3

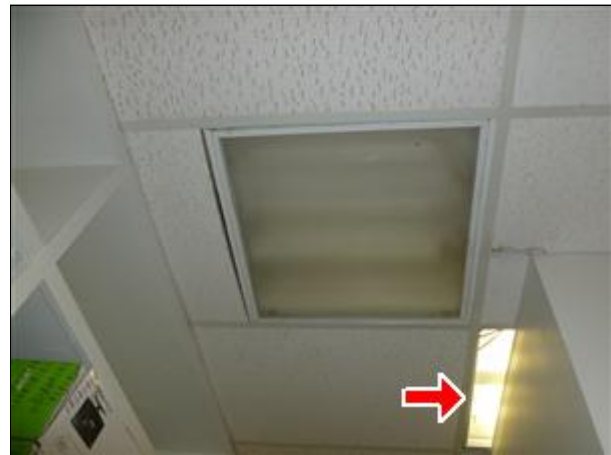
The bathroom frame wall interferes with the location of the suspended ceiling light fixture. (Suite 2).

Ceiling/Wall - Suite 2

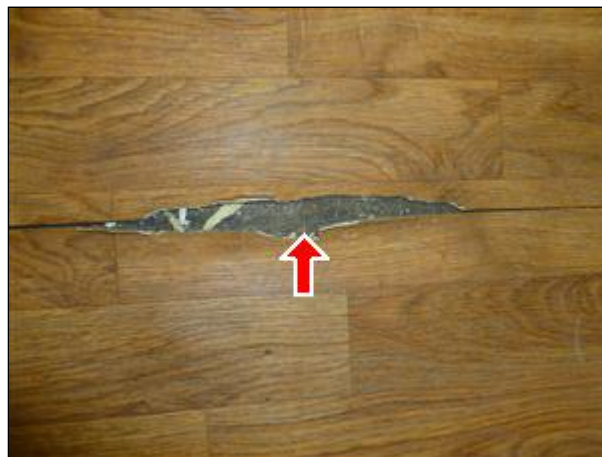
3.2 The veneer flooring is starting to de-laminate to the rear storage area. This condition is a tripping hazard. (Suite 2).

Damaged Flooring - Suite 2

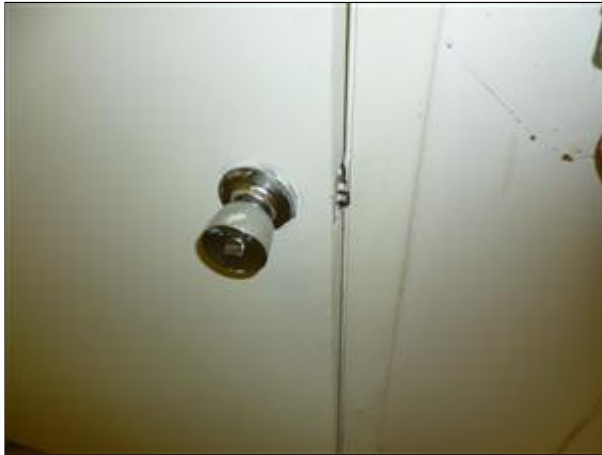
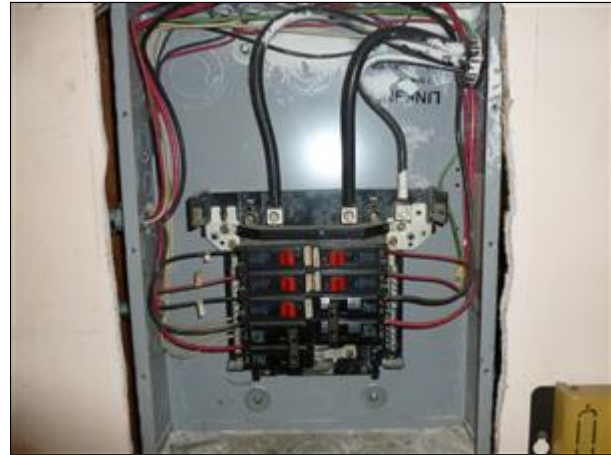
3.4 The door to rear work area is hard to open. (Suite 3).

Difficult Door - Suite 3

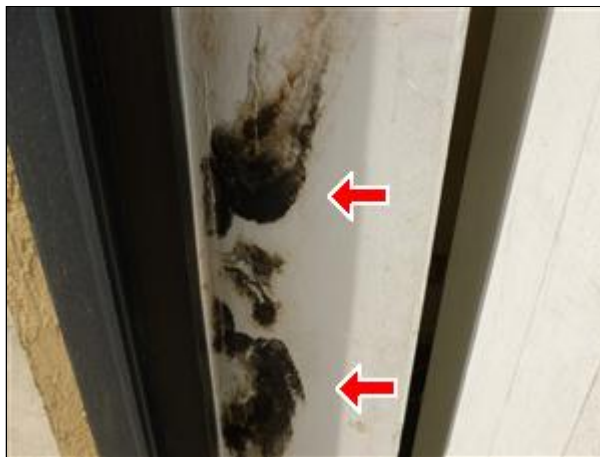
3.8 There is evidence of live mold growing on the front entry door jamb. (Suite 3 - See Separate Mold Assessment Report). This mold will require professional remediation.

Mold Growth - Suite 3

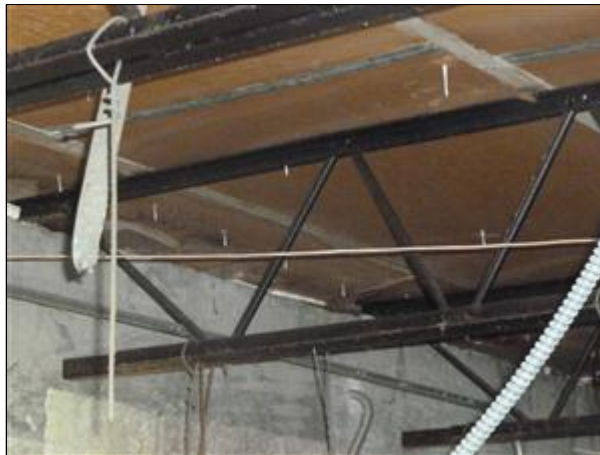
4.5 The roof consists of built-up roofing over insulation panels over metal deck attached to the top of steel bar joists.

Roof Structure

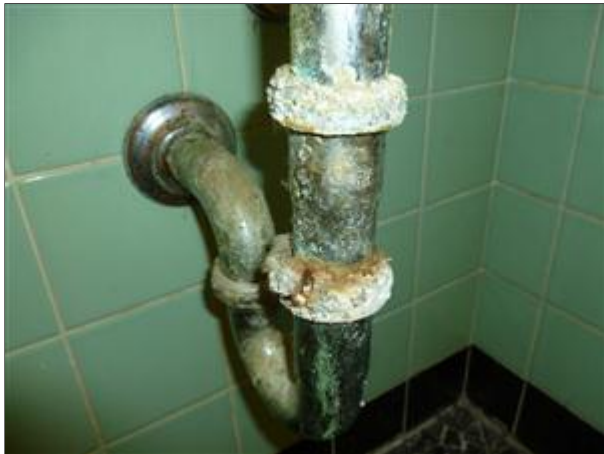
5.0 The drain is corroded to the West bathroom. (Suite 3).

Corroded Drain - Suite 3

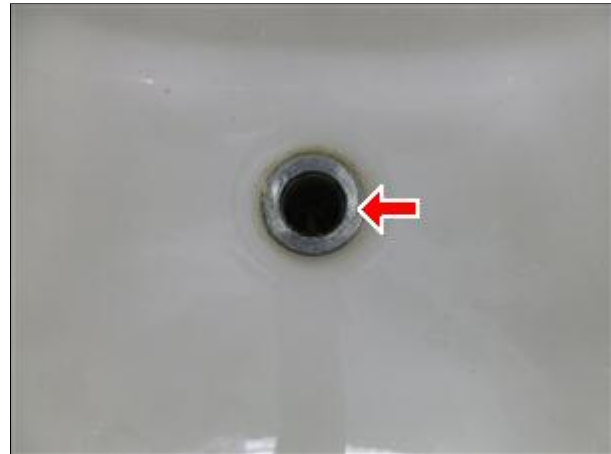
The drain is missing to the bathroom sink basin. (Suite 2).

Missing Drain - Suite 2

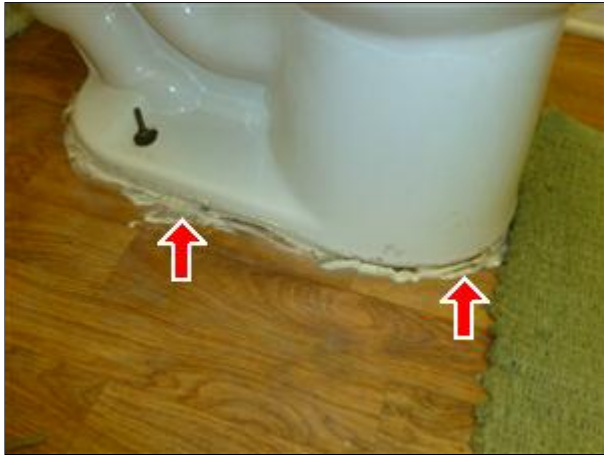
5.1 The caulking around the toilet indicates a possible problem with the toilets wax ring. (Suite 2).

Toilet Caulking - Suite 2

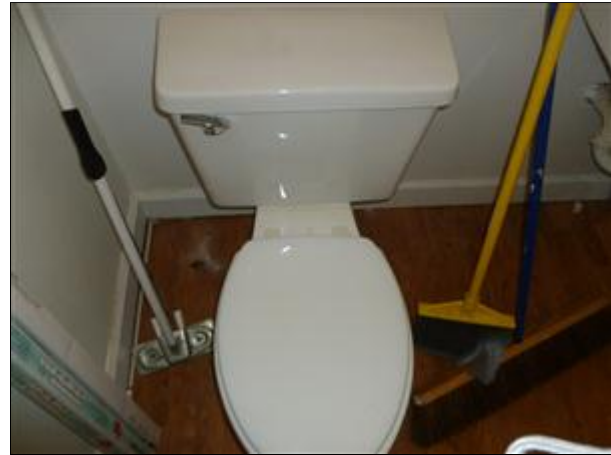
The toilet in the West bathroom is not operational. (Suite 2).

Inoperable Toilet - Suite 2

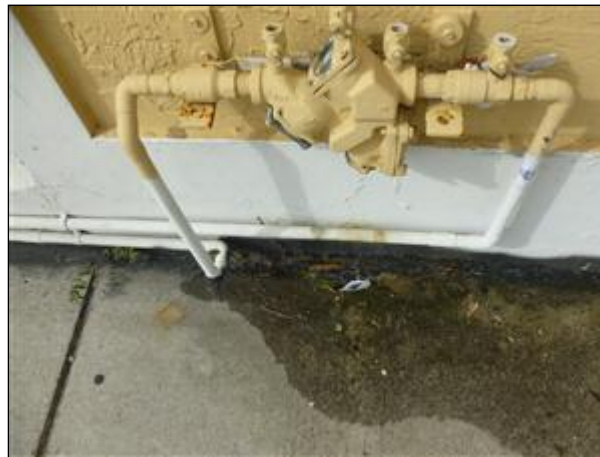
The back flow preventer located at the East elevation is leaking.

Leaking Back Flow Preventer - East Elevation

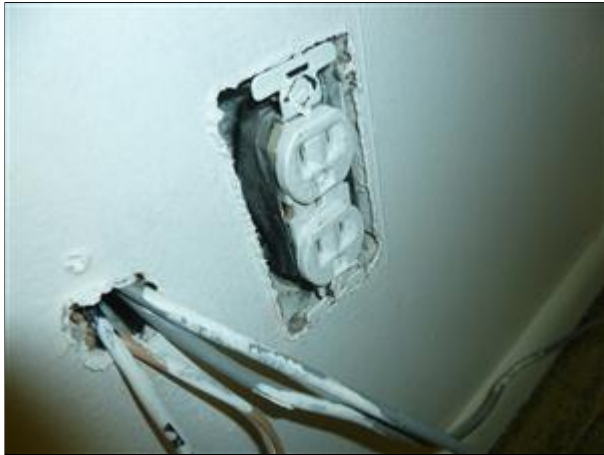
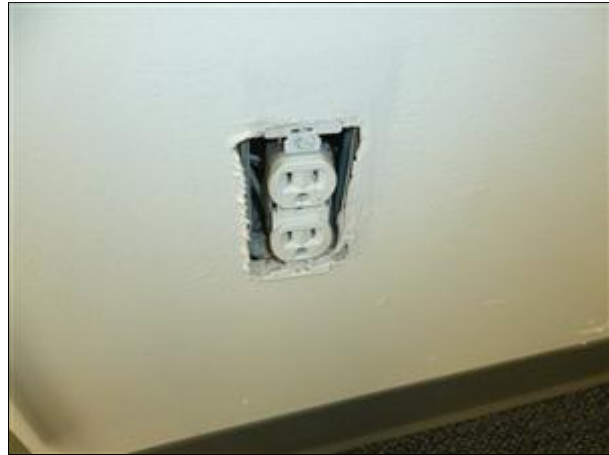
There are several electrical trim plates missing. (Suite 3).

Missing Trim Plate - Suite 3

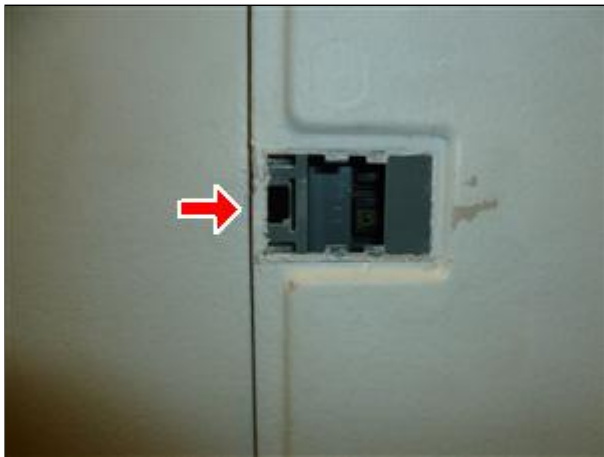
The opener is damaged to the electrical panel. (Suite 2).

Damaged Panel Cover - Suite 2

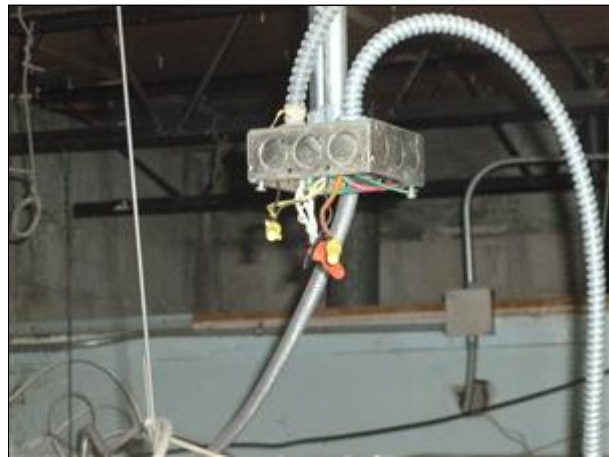
6.3 There is an open electrical junction located in the suspended ceiling. (Suite 3).

Open Junction Box - Suite 3

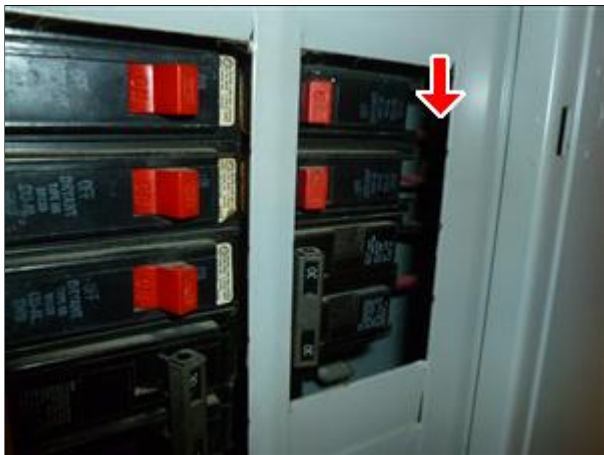
The electrical panel box is not flush with the cover and the interior is partially exposed. (Suite 3).

Exposed Panel - Suite 3

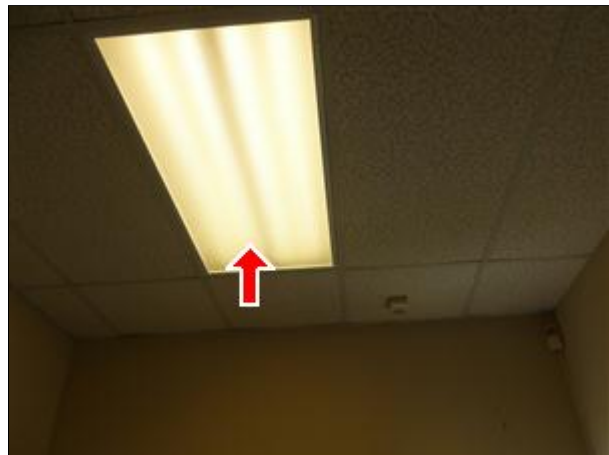
The ceiling light fixtures are deteriorated. Recommend new installation. (Suites 2 and3).

Damaged Light Fixture - Suite 3

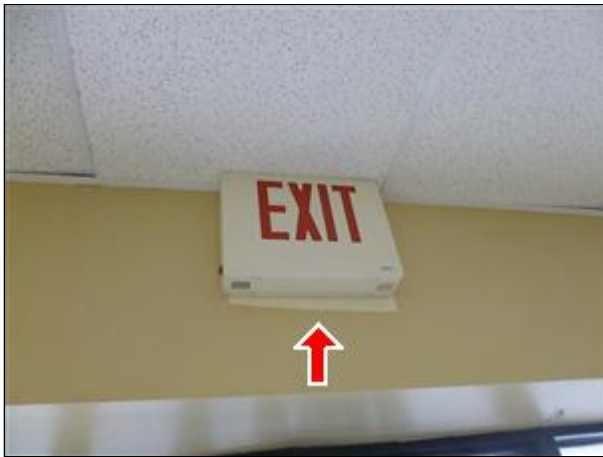
The exit light was not lit. (Suite 1).

Non-Lit Exit Light - Suite 1

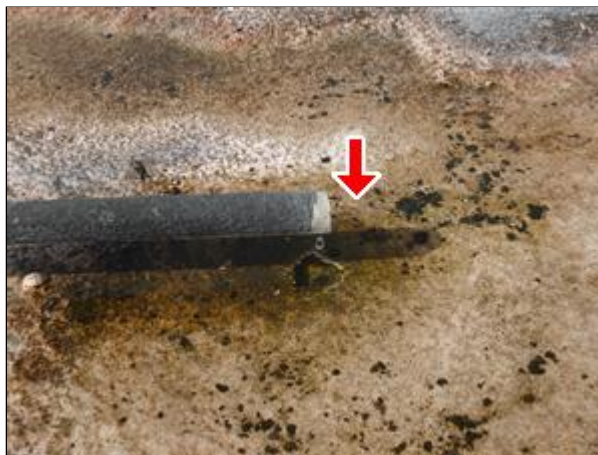
7.3 The AC condensate drain is broken to the package unit located on the roof. This is causing water to collect on the roof. (Suite 2).

Broken AC Drain - Roof

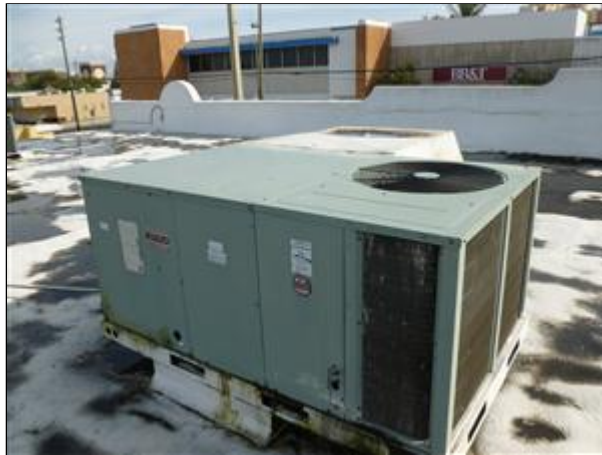
7.5 Each suite contains a separate central air conditioning system. The system for suites 1 and 3 contain a concealed air handler in the suspended ceiling system and roof mounted condensing unit. The system for Suite 2 is a roof mounted package unit. The systems are cooling, however the systems are aged and have reached the end of their economic life.

AC Package Unit - Suite 2

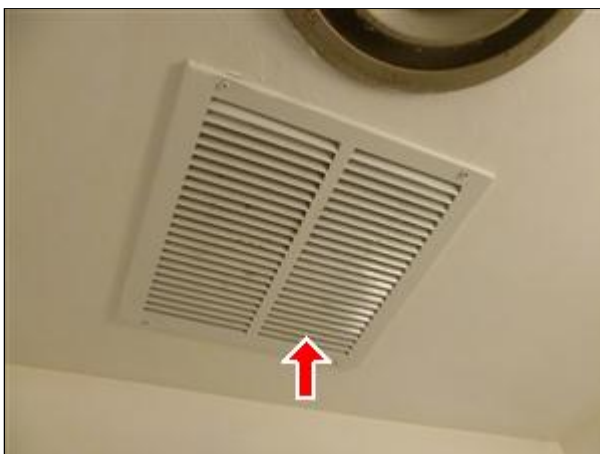
8.0 The restroom vent fan vents into the suspended ceiling system and then to a vent thru the roof. The vent in this restroom is not ducted. (Suite 3).

Bathroom Vent - Suite 3
