Inspection Report

RIVIERA BEACH REDEVELOPMENT AGENCY

Property Address:
2601 Broadway
Suites 1, 2, 3
Riviera Beach FL 33404

BEATTY INSPECTION SERVICES

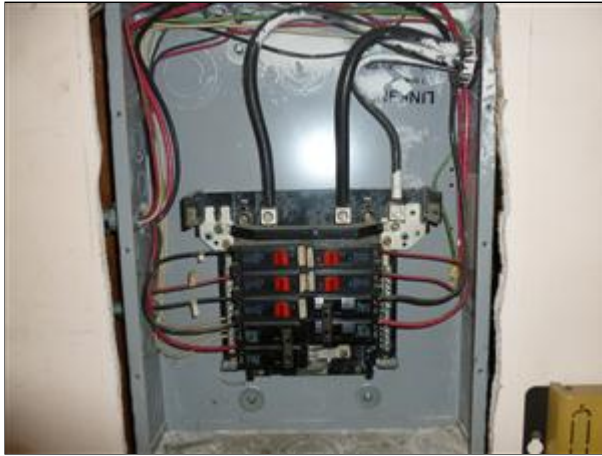
Electrical Panel - Suite 3

6.6 The electrical system is overhead and consists of 120/240 volt, single-phase, 3 wire system. The main electrical service entrance is 125 amps. The main electrical conductors are copper and all interior wiring is of copper conductors. The main panels are located inside each suite. Each suite is separately metered. The meters and disconnects are located on the rear exterior wall. (The panel in Suite 1 was not accessible and was not opened).
